Re: Testing of RF85 Treated AISI 52100 Steel Specimens

RF85 Project

**Timken Engineered Surfaces Lab (TESL)
The University of Akron
12-09-2016**

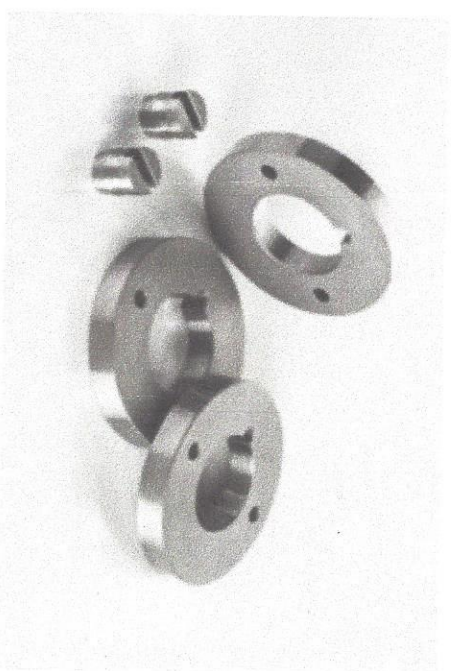
Samples: MPR Rollers

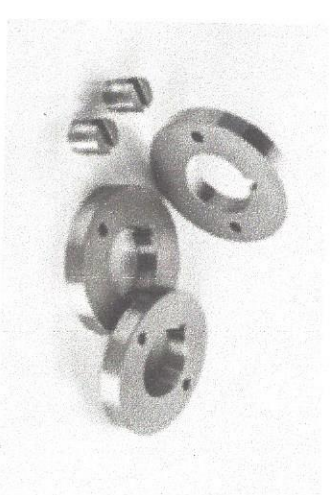
MPPR Test Conditions

Test Condition	
Speed	3.5m/s
SRR	10%
Load	600N (2.0Gpa)
Temperature	40°C
Oil	PAO ISO-10

Test Rollers	
Untreated Rollers	Un-01, Un-02, Un-03
RF85 treated Rollers	Tr-01, Tr-02, Tr-03
Test Rings	
5210 Case Carburized

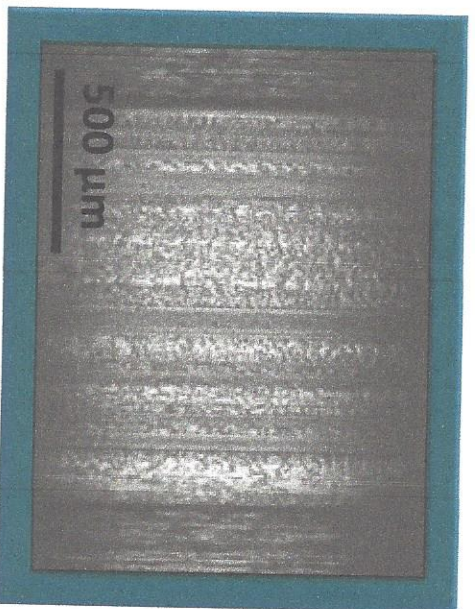
Images of untreated and RF85 treated rollers during the test
After running 0.5×10^6 cycles

Tests	0.5 X 10 ⁶ cycles	1.5 X 10 ⁶ cycles	2.5 X 10 ⁶ cycles	3.5 X 10 ⁶ cycles	5.0 X 10 ⁶ cycles
Un-01	None	None	None	MC	ME MC
Un-02	None	None	ME	ME MC	N/A
Un-03	None	None	ME MC	ME MC	ME MC
Tr-01	None	None	None	None	ME
Tr-02	None	None	None	None	ME MC
Tr-03	None	None	None	None	ME MC

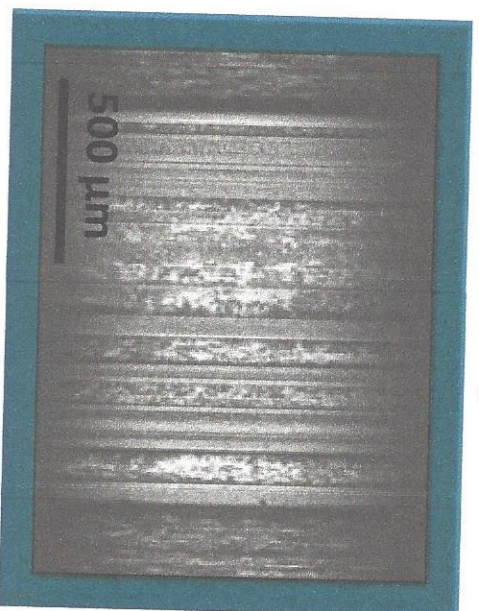
Un-01

Images of untreated and RF85 treated rollers during the test
After running 1.5×10^6 cycles

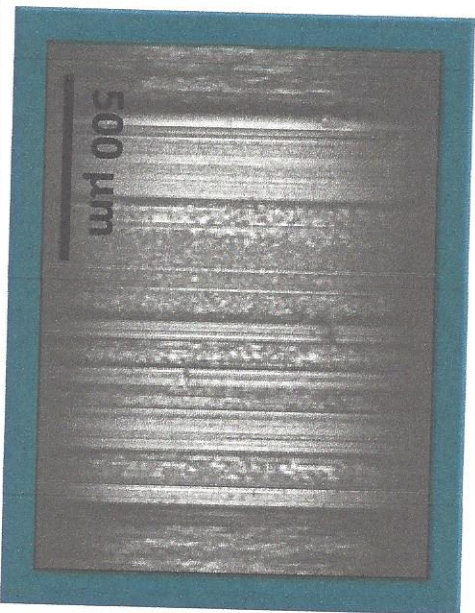
Un-01

Images of untreated and RF85 treated rollers during the test
After running 2.5 X 10⁶ cycles

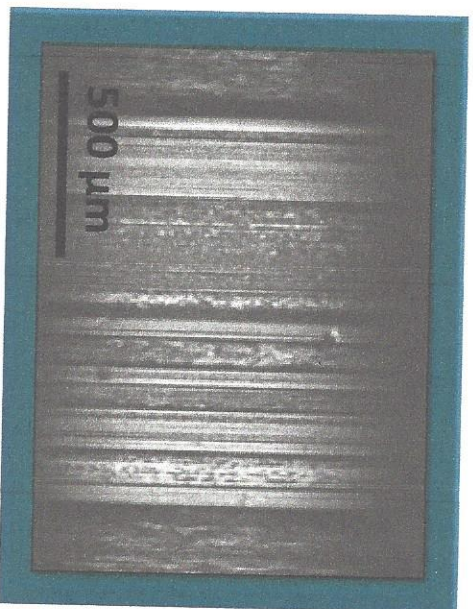
Un-01

Images of untreated and RF85 treated rollers during the test
After running 3.5×10^6 cycles

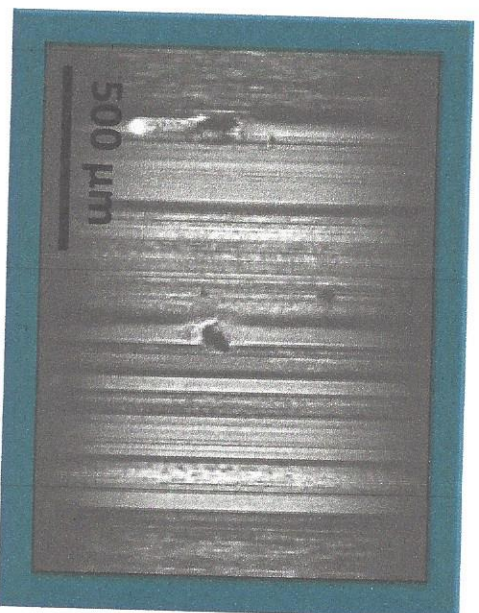
Un-01

Images of untreated and RF85 treated rollers during the test
After running 5×10^6 cycles

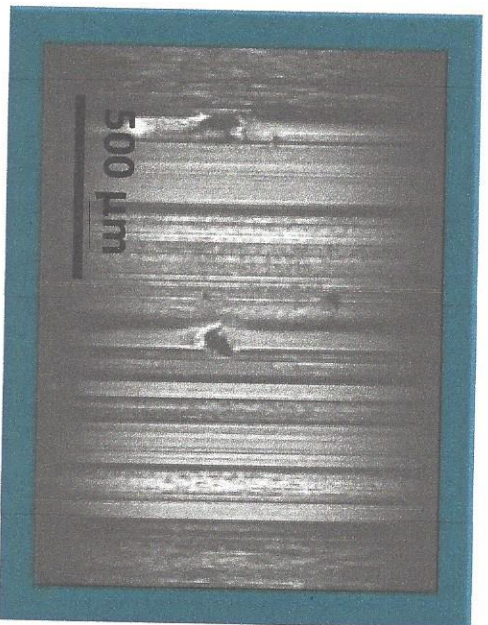
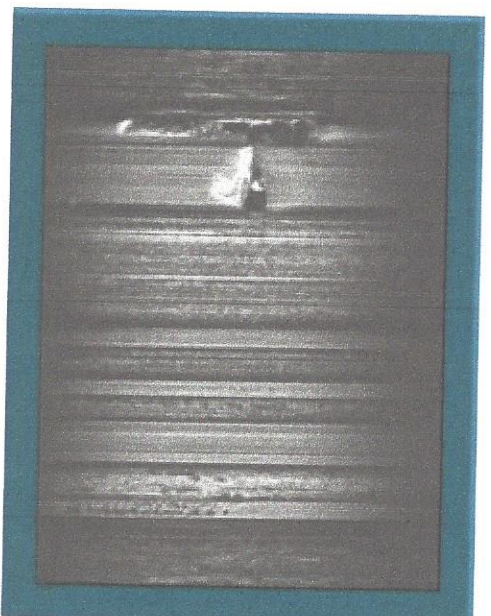
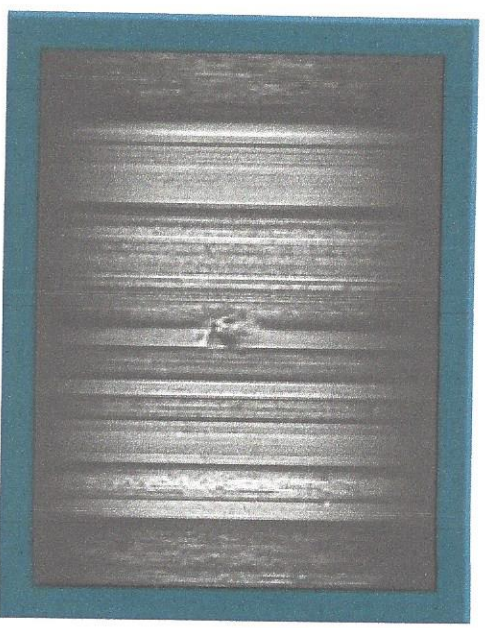
Un-01

More images of untreated and RF85 treated rollers at end of test (5 X 10⁶ cycles)

Different locations of the same roller

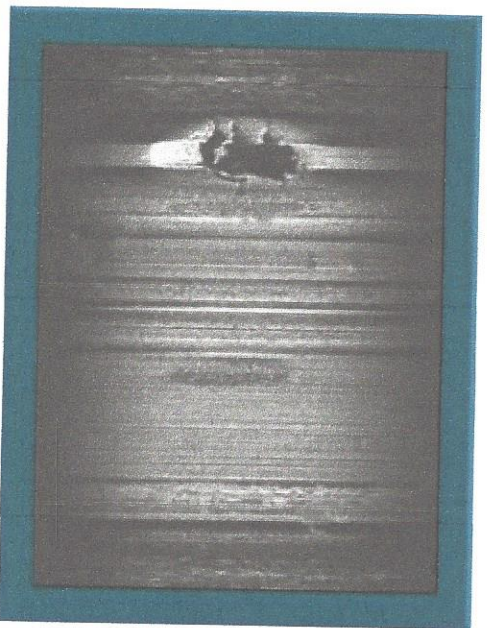
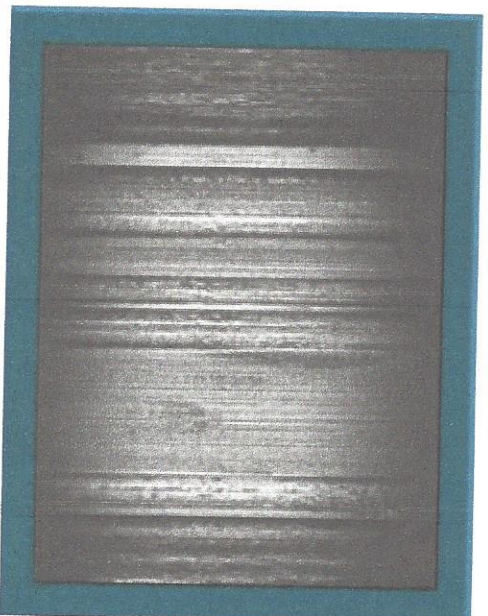
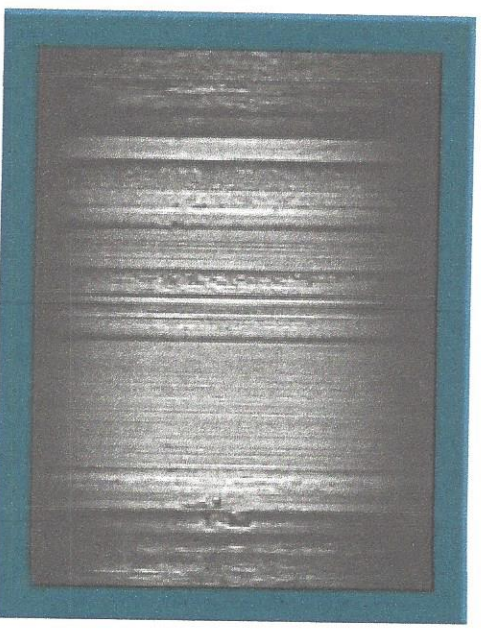
Tr-01

Different locations of the same roller

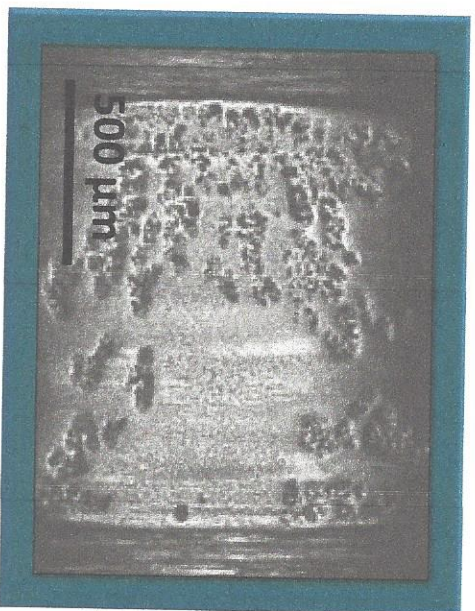
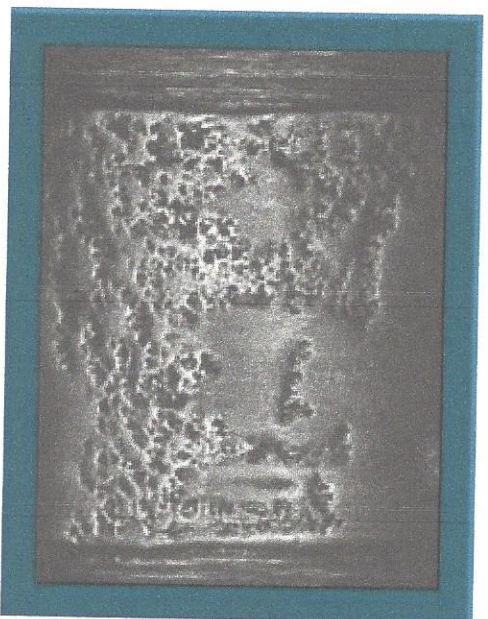
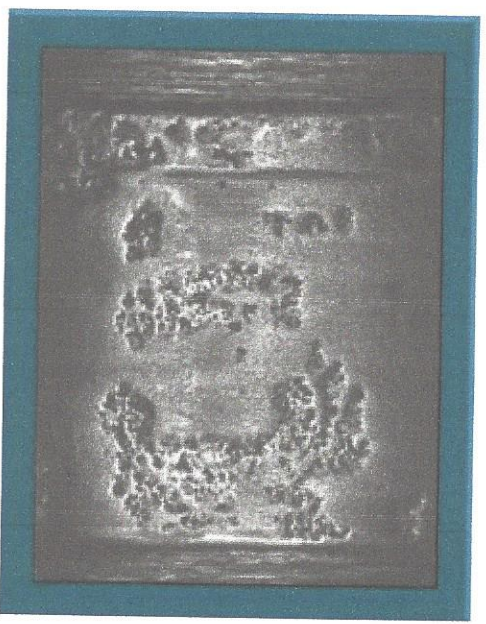
More images of untreated and RF85 treated rollers at end of test

Un-02 (3.5 X 10⁶ cycles) (End the test at 3.5 X 10⁶ cycles because of surface damage)

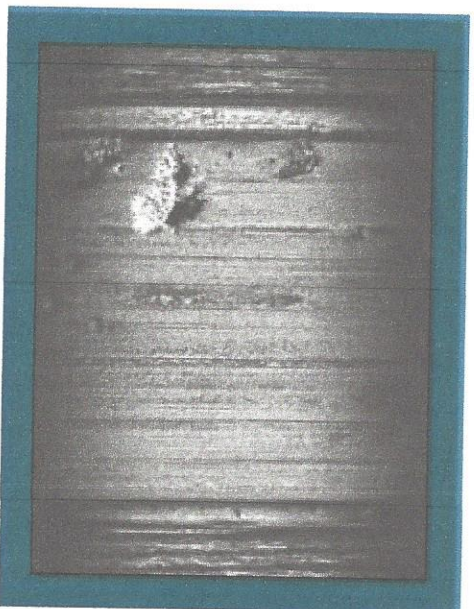
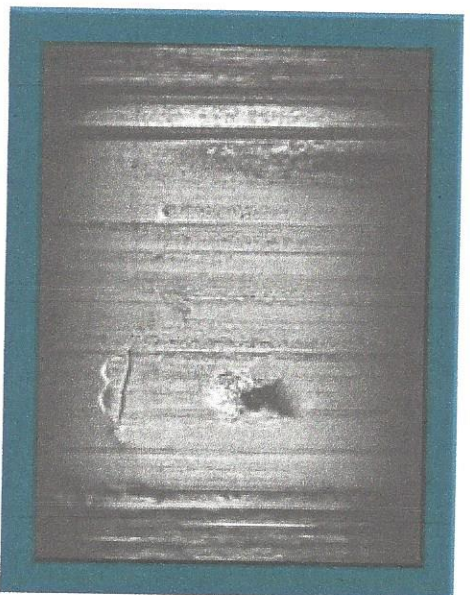
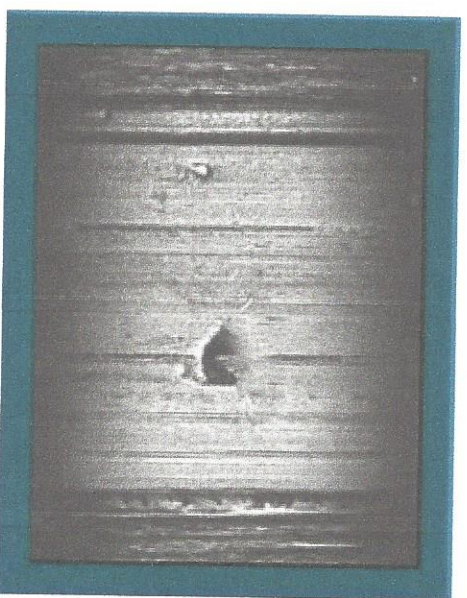
Tr-02 (5.0 X 10⁶ cycles)

Different locations of the same roller

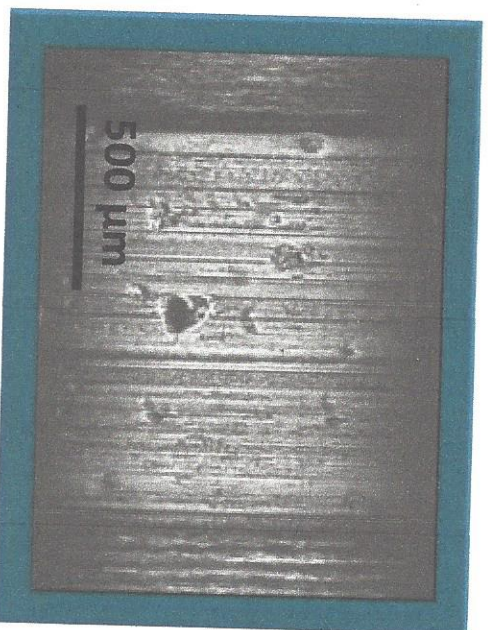
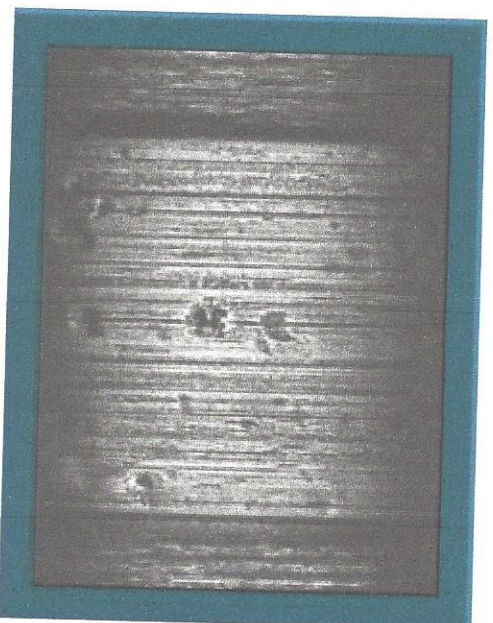
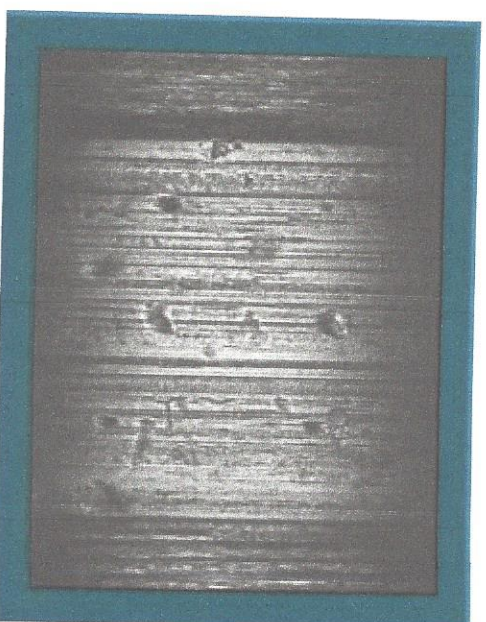
Un-03

More images of untreated and RF85 treated rollers at end of test (5 X 10⁶ cycles)

Different locations of the same roller

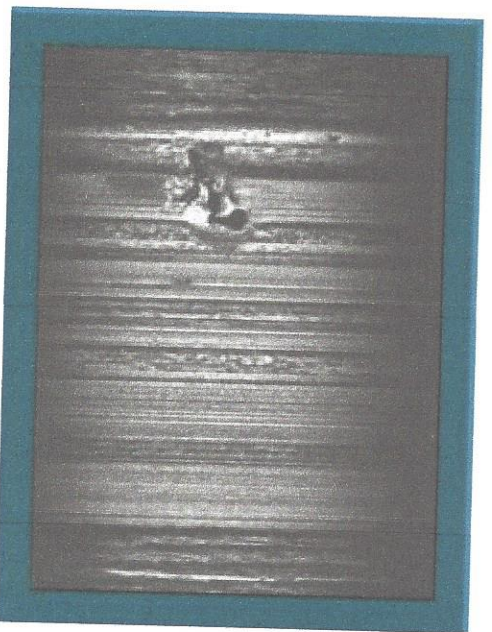
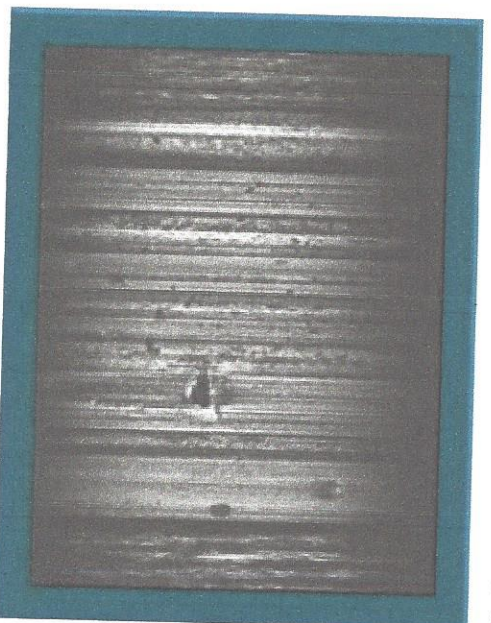
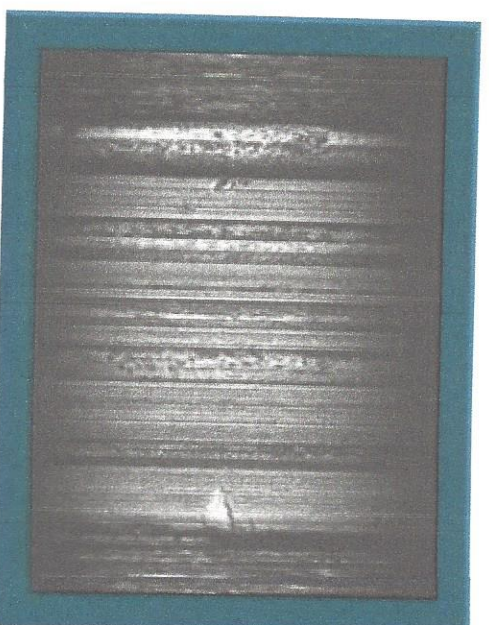
Tr-03

Different locations of the same roller

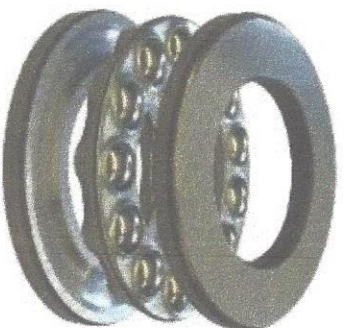
Samples: Thrust ball bearings (51306)

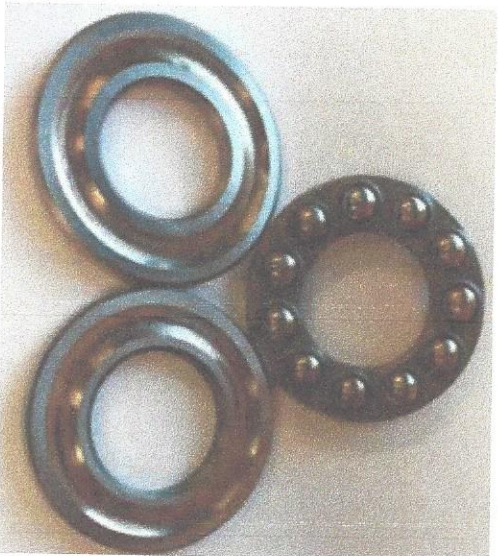
Un-01 (1.35h)

**Images of untreated and RF85 treated thrust bearing (51306)
after scuffing test**

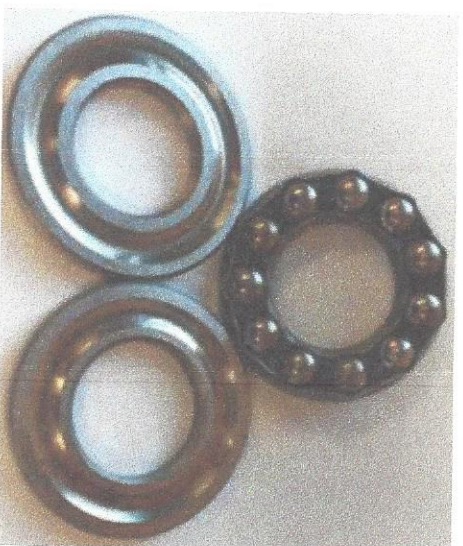
Un-04 (1h)

Images of untreated and RF85 treated thrust bearing (51306) after scuffing test

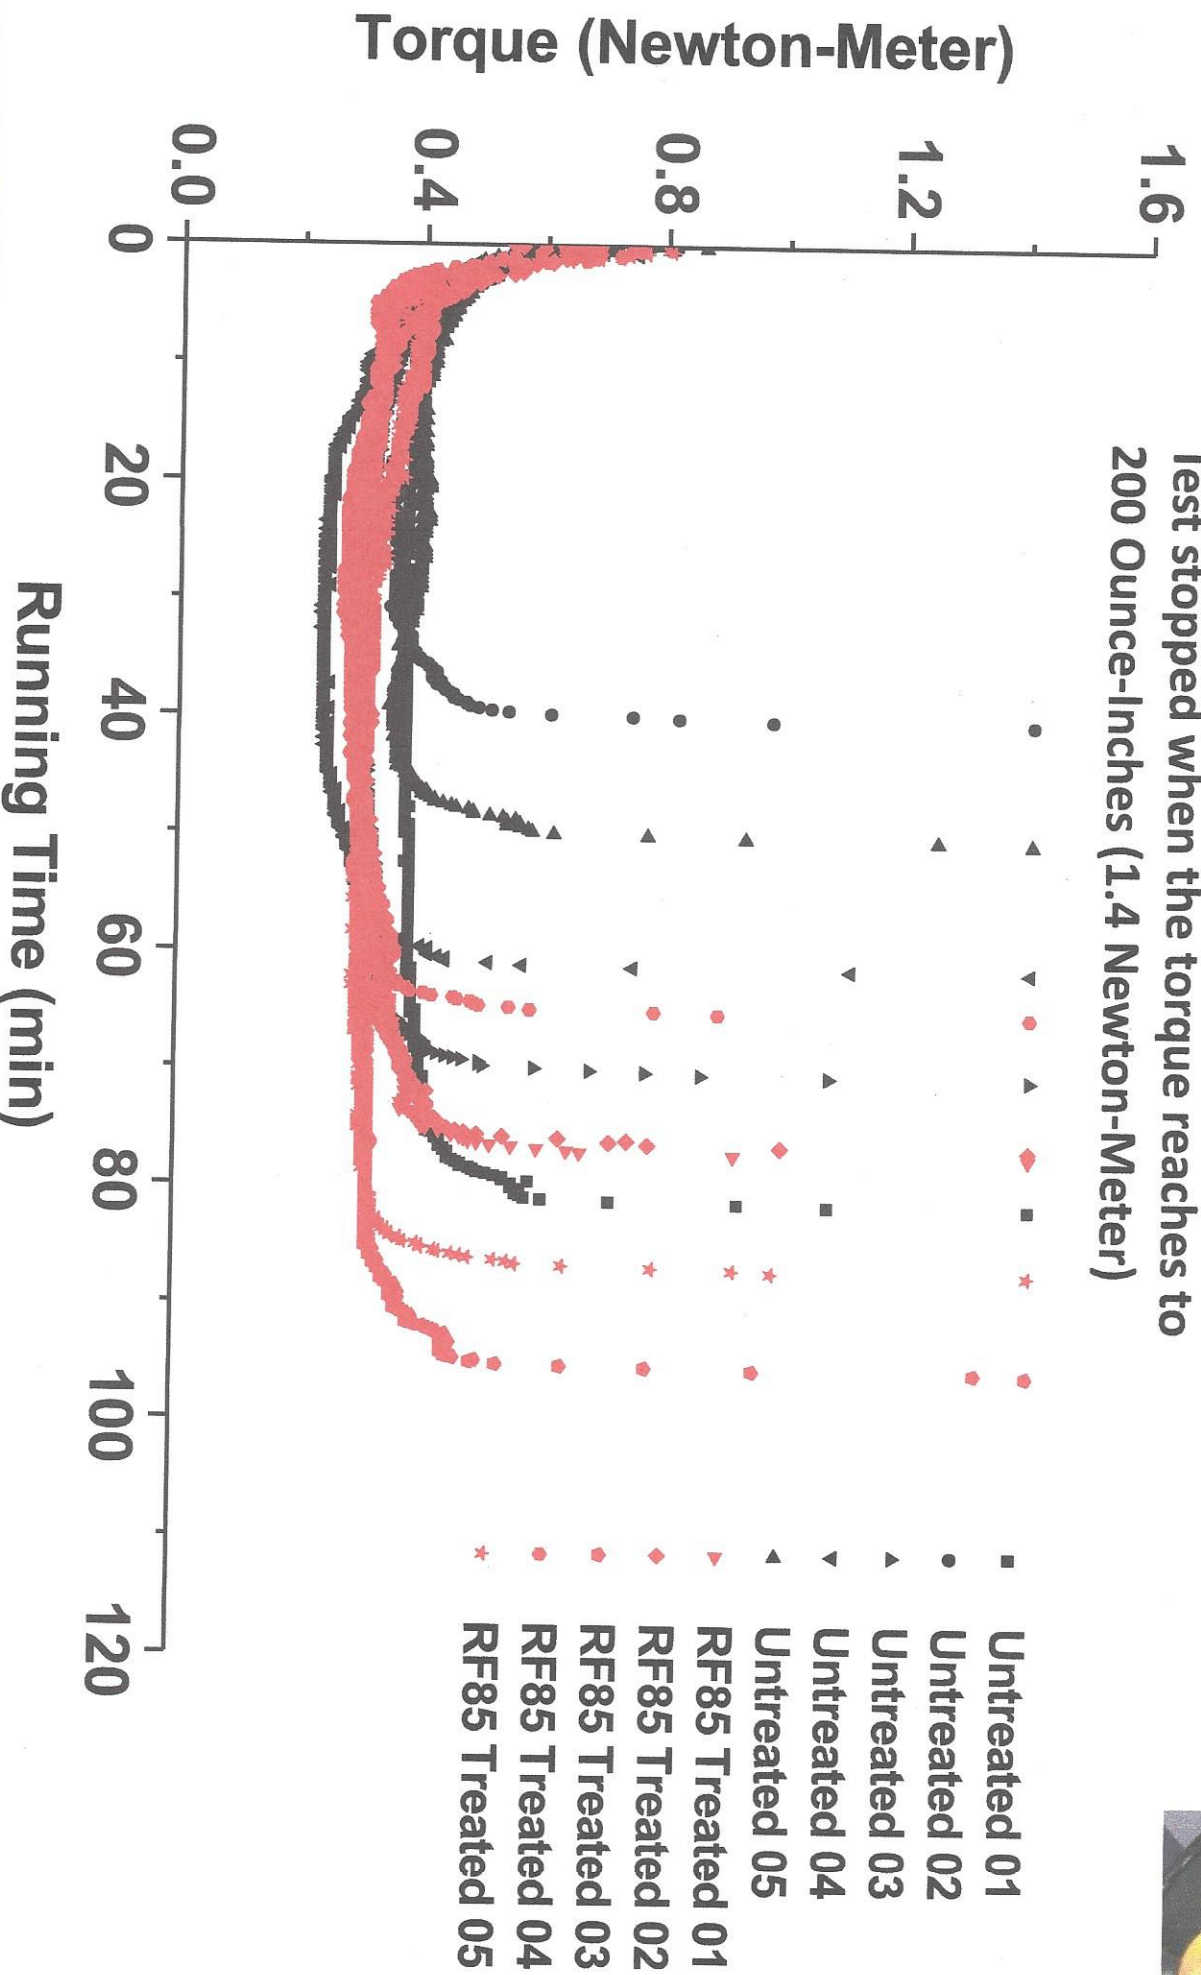
Torque VS. Running Time

Test stopped when the torque reaches to 200 Ounce-Inches (1.4 Newton-Meter)

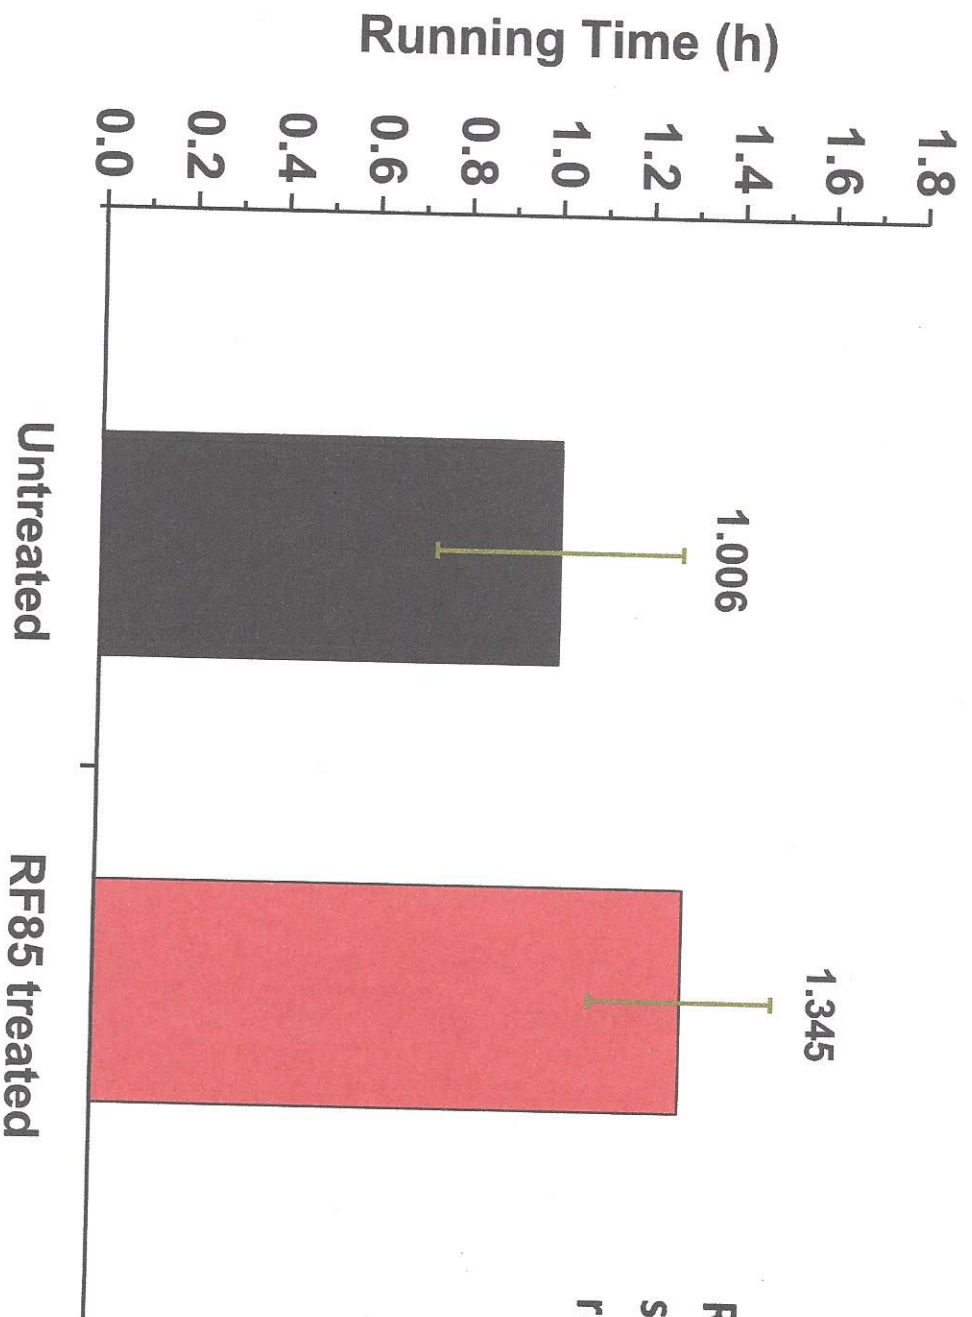
Running time for the torque reaches to 200 Ounce-Inches (1.4 Newton-Meter)

RF85 Treated bearing showed ~34% longer running time.

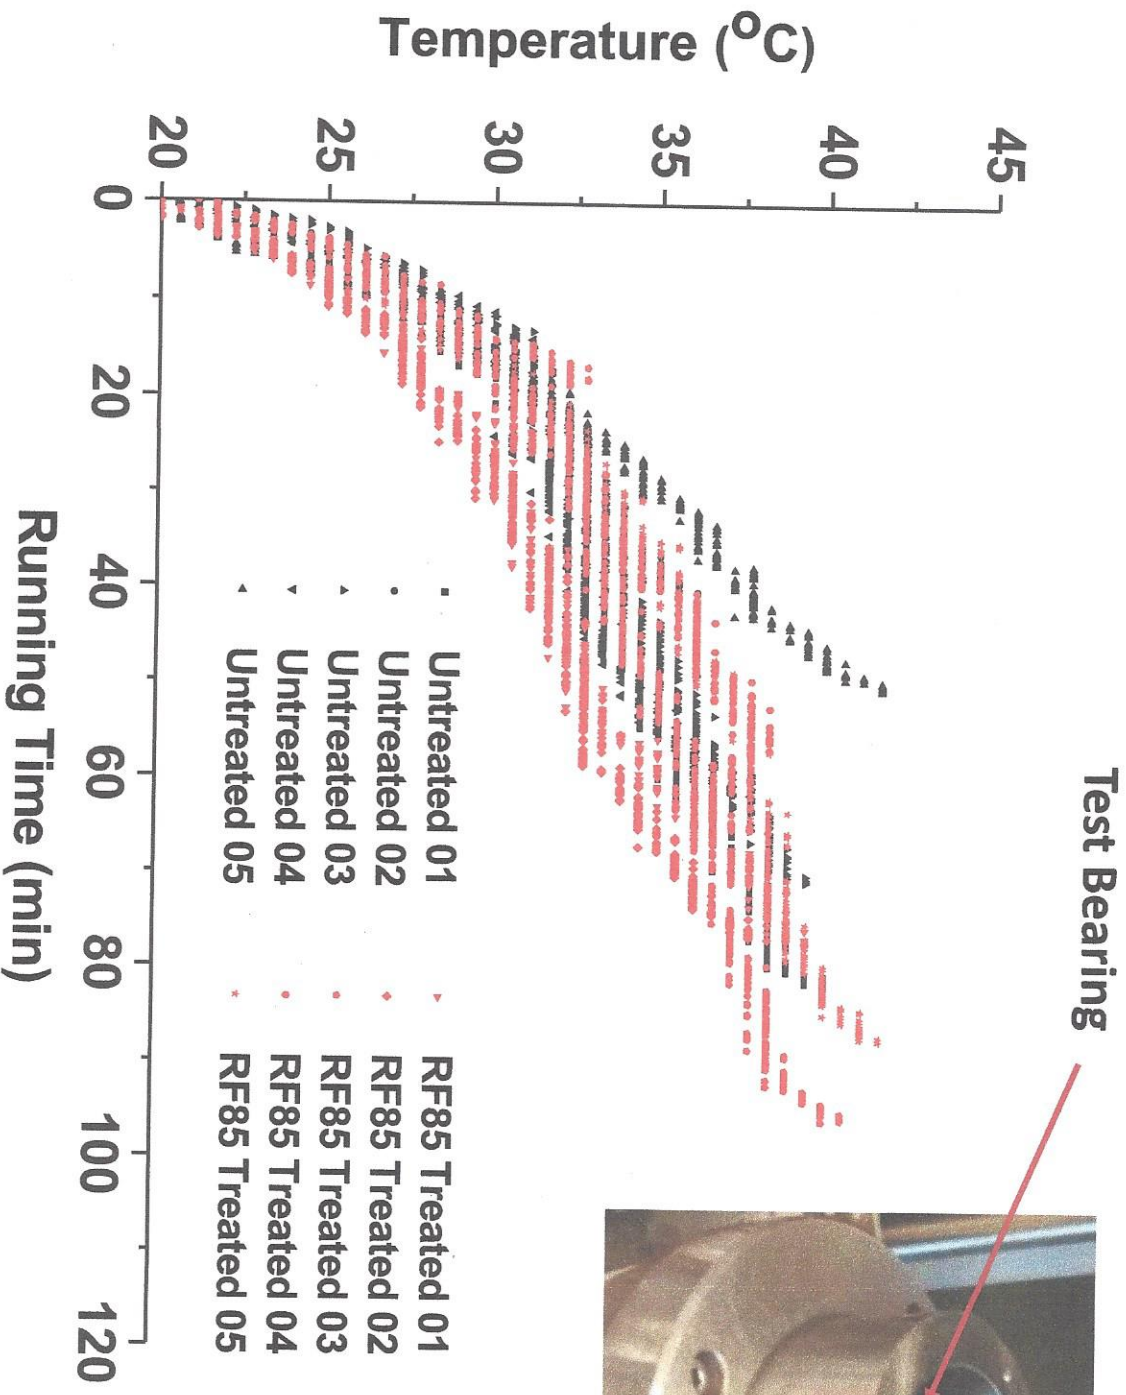
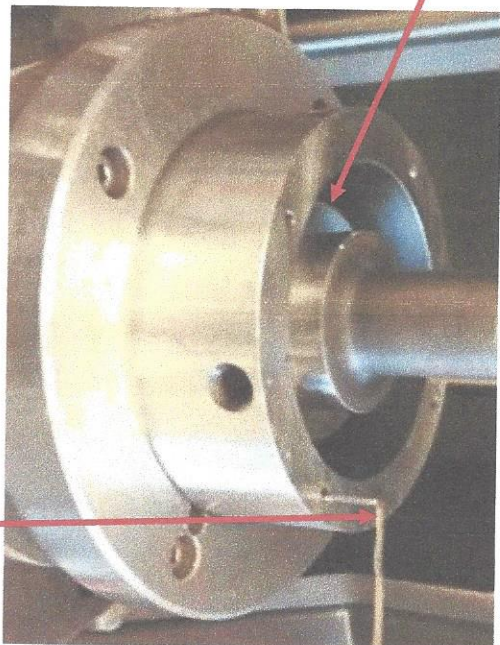
Bearing Holder Temperature VS. Running Time

Thermocouple
measures *in situ*
temperature

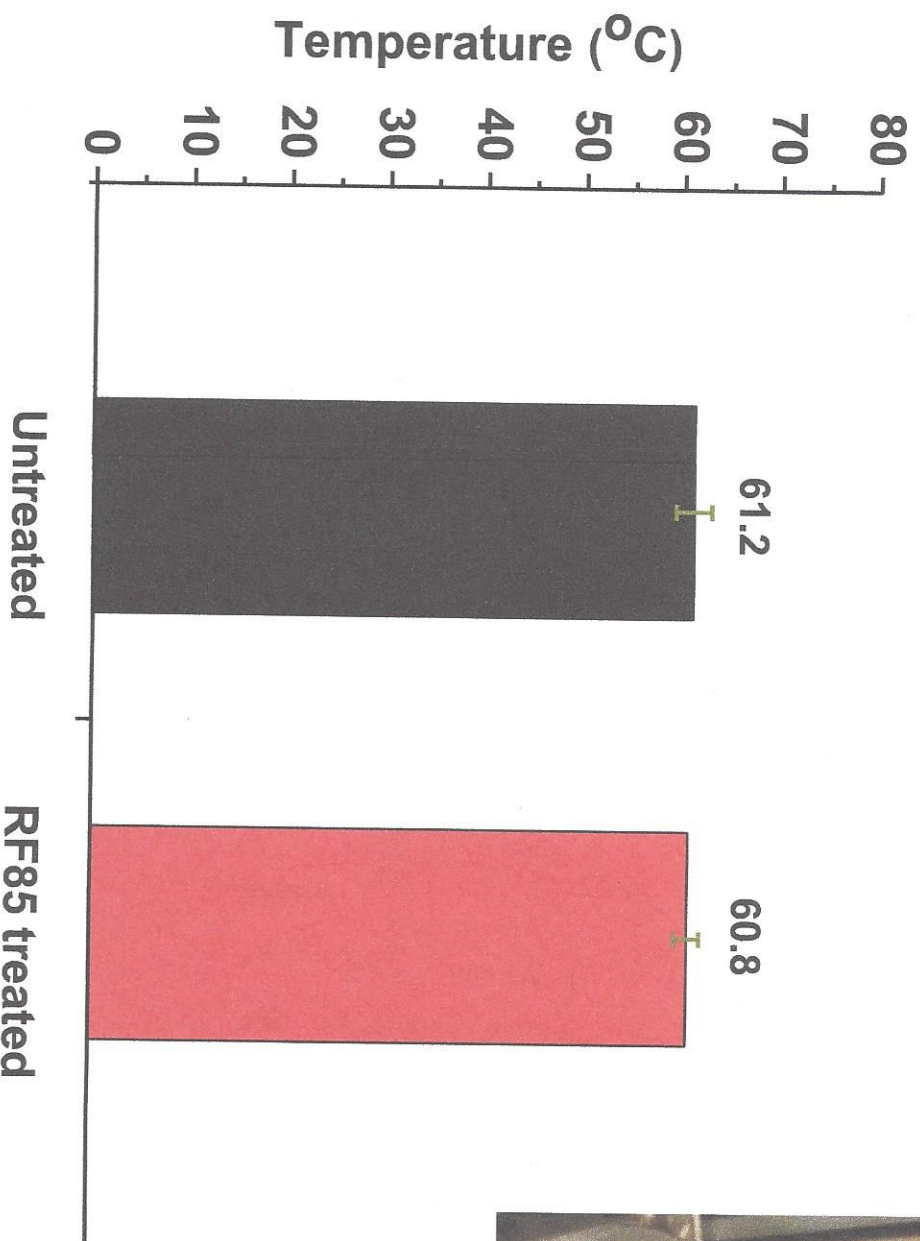
Inside Temperature at the End of Tests

Thermocouple
measures
inside
temperature
after each test

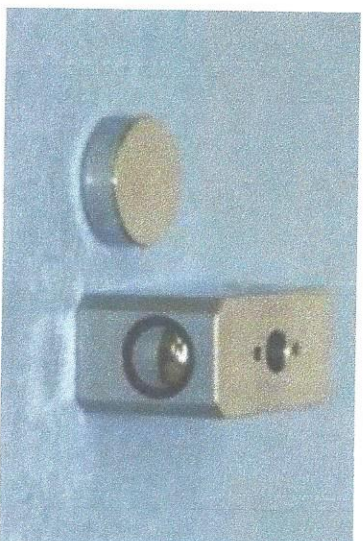
Samples: PCS HFRR 52100 disk and 52100 ball

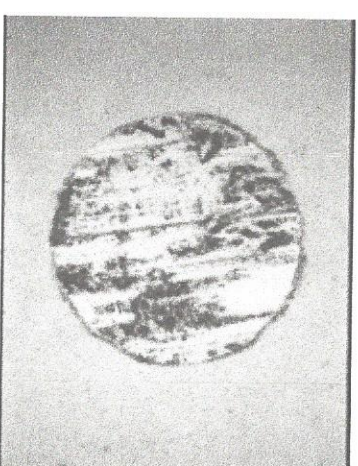
Ball's wear volume was calculated by diameter of wear scar.

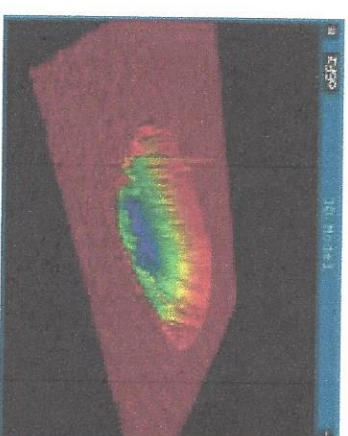
Disk's wear volume was measured by Zygo New View 7300.

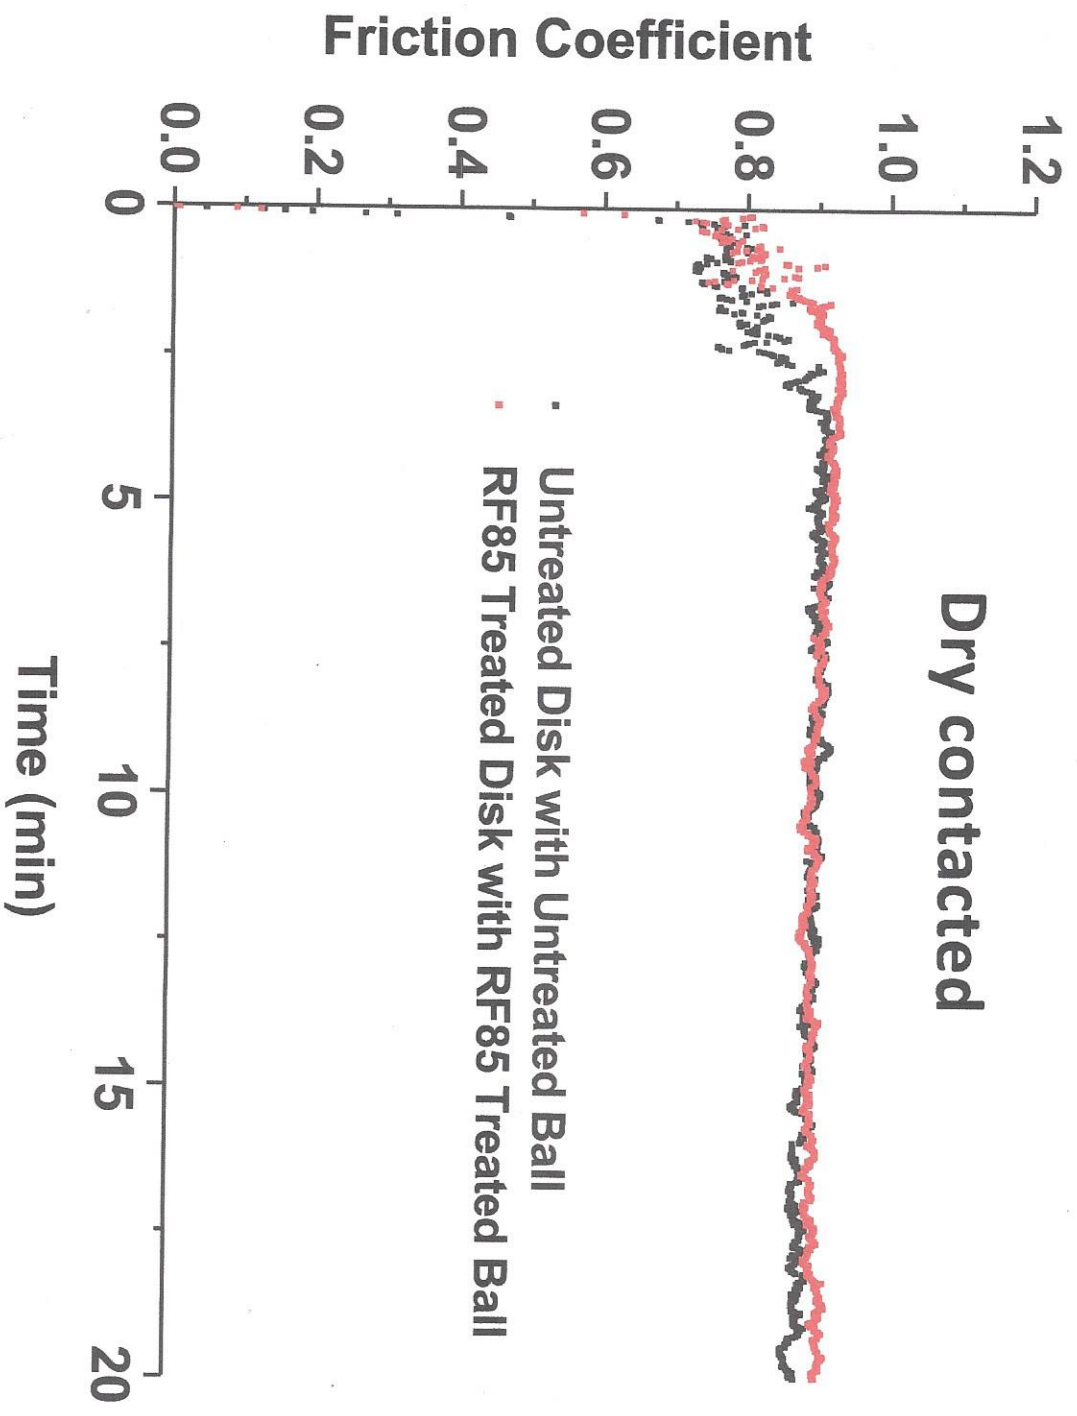
Coefficient of Friction VS. Running Time

Similar friction coefficient.

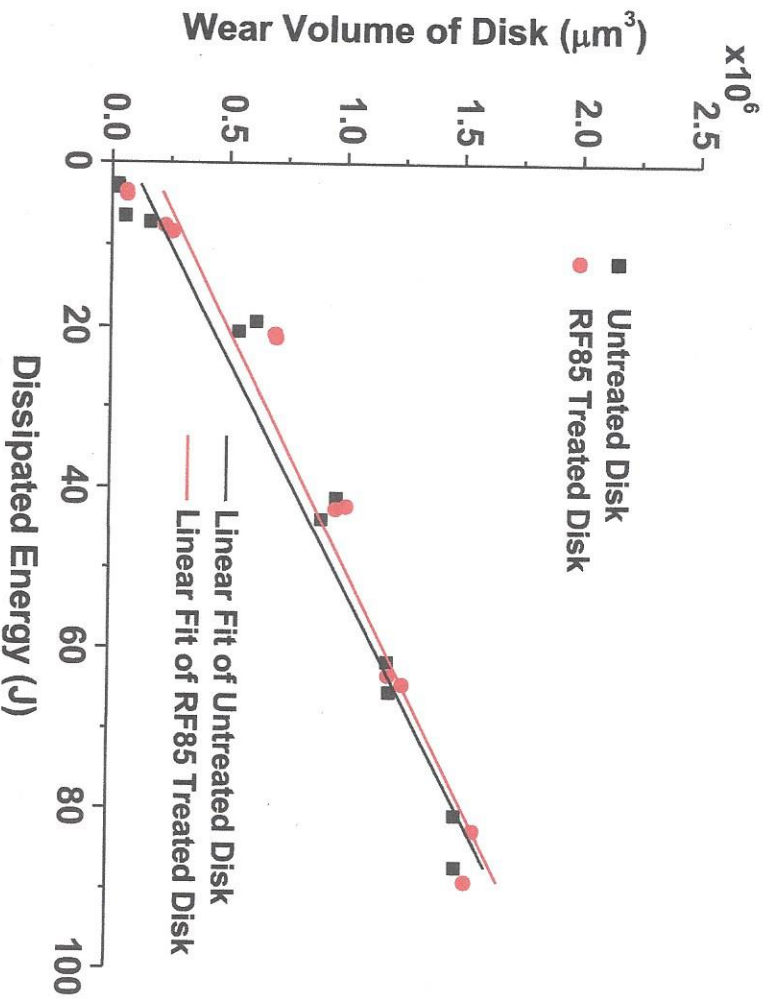
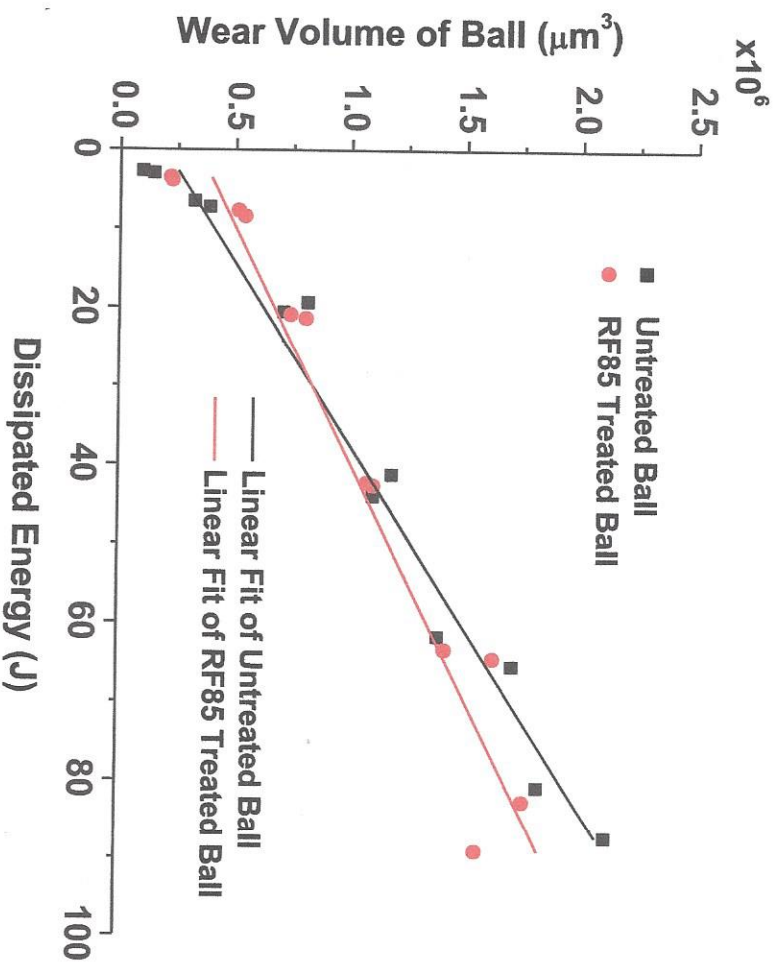
Wear Volume VS. Dissipated Energy

Similar wear rate.
